TS-AMD-86612-3
September 1987

AERIAL PHOTOGRAPHIC ANALYSIS OF
THE UNION OIL REFINERY SITE

Lemont, Illinois

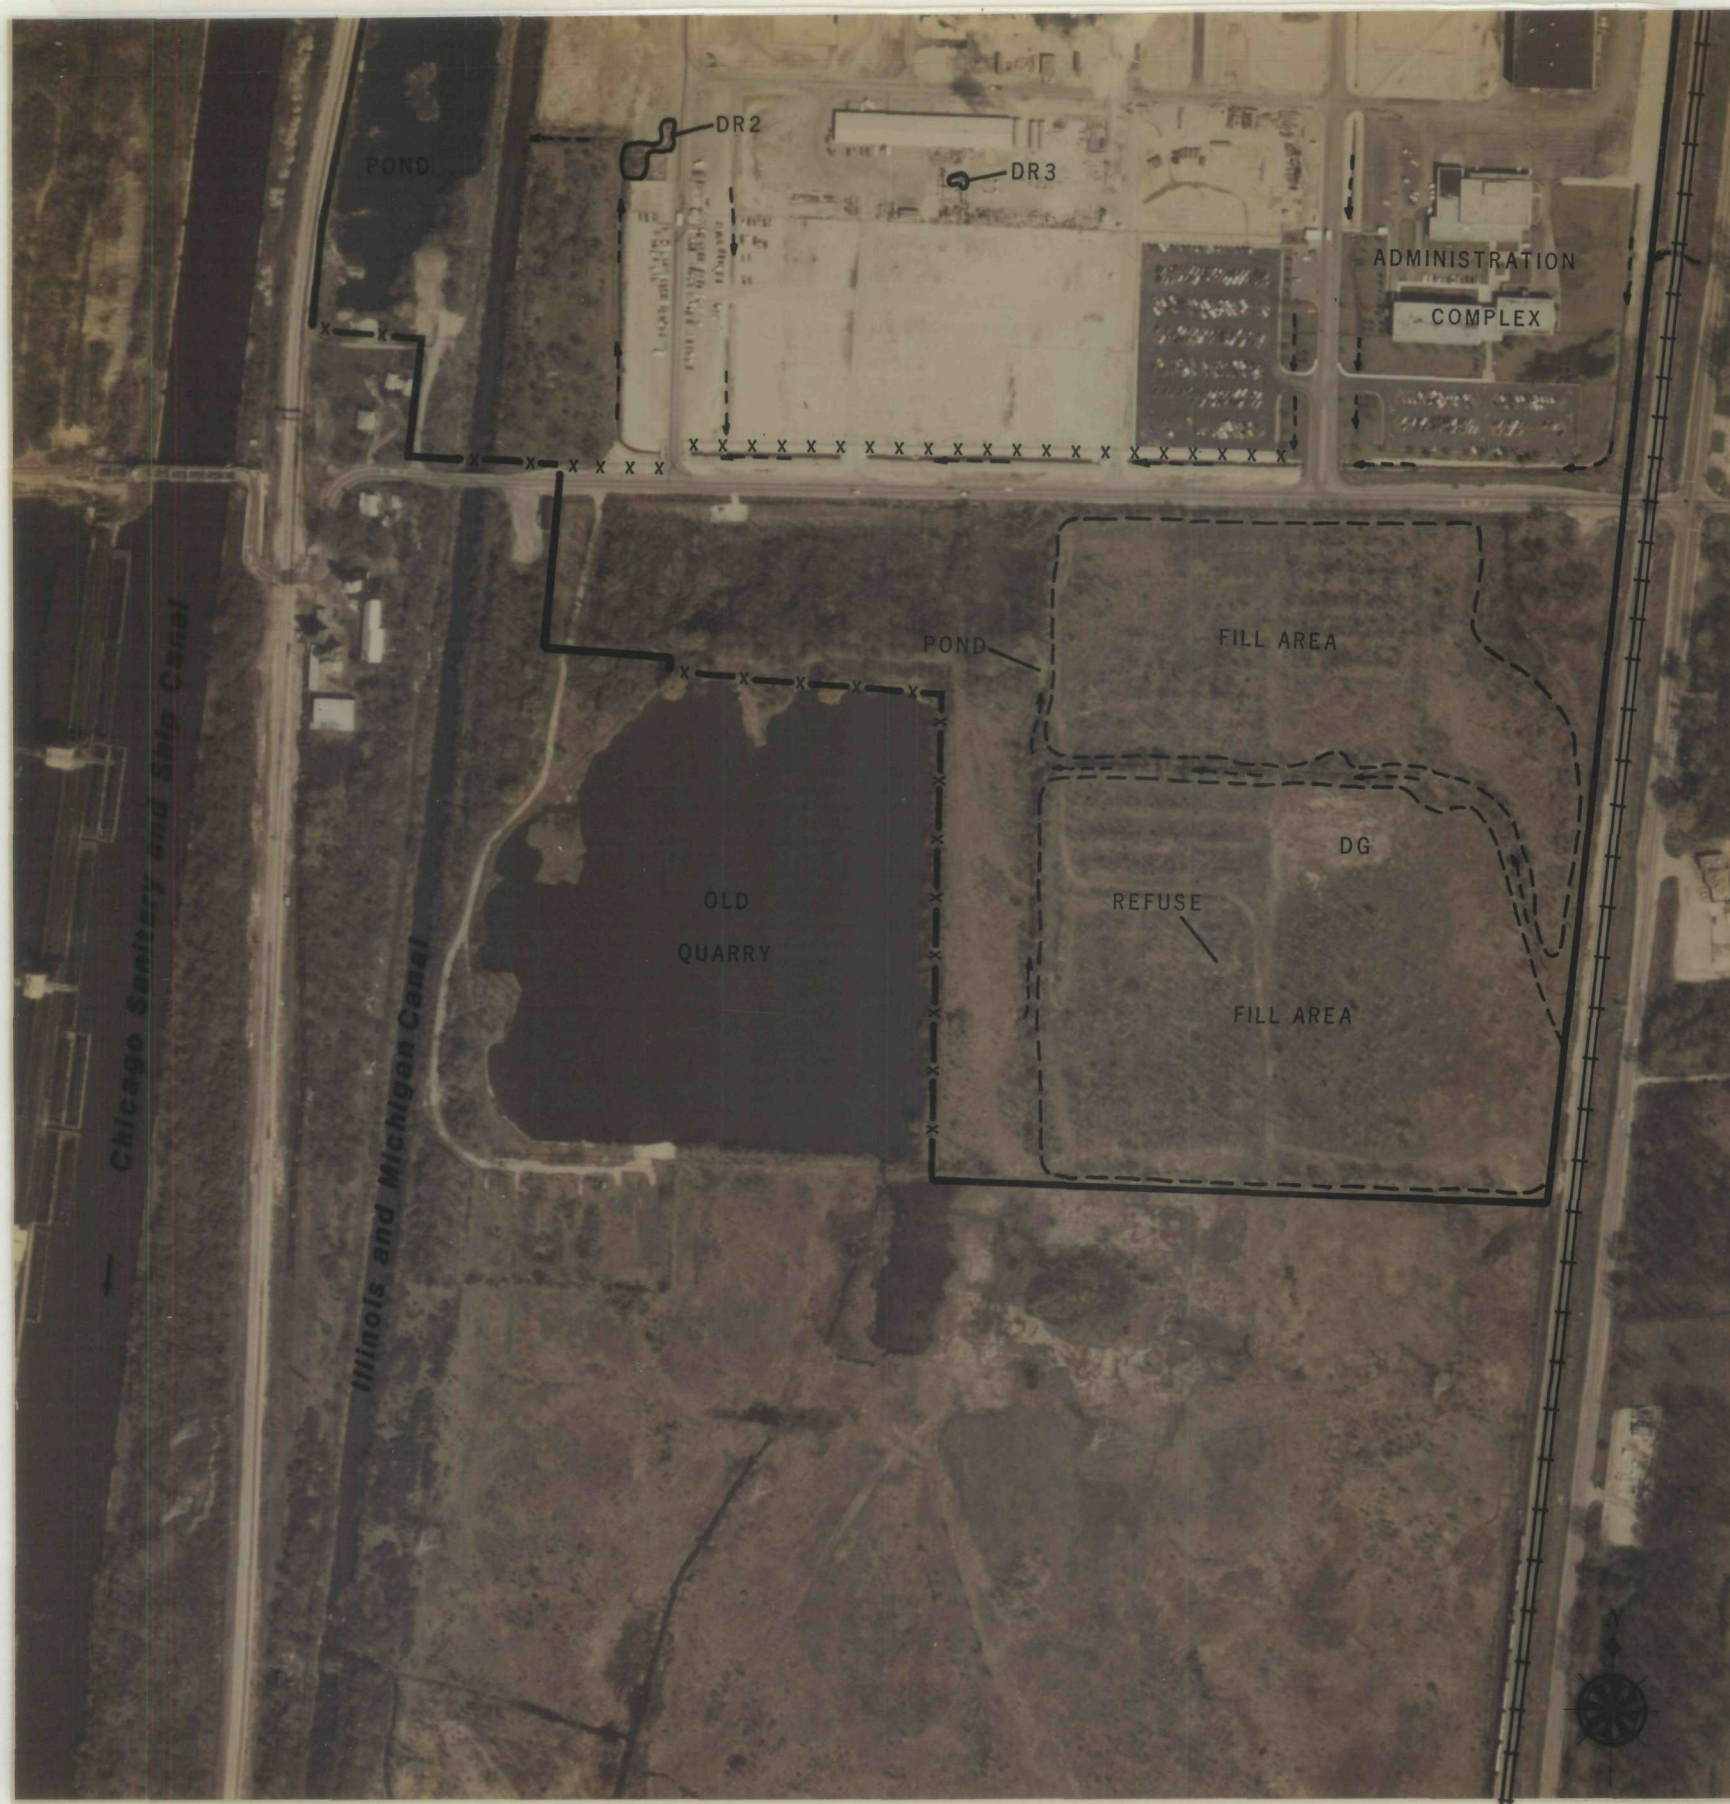
Figure 11. Union Oil Refinery site, April 17, 1986 (9 of 9). Approximate scale 1:5,000.

DR2 and 3 - Drums at this point are stored immediately above a drainage ditch which carries runoff from the site into the Illinois and Michigan Canal. Any leakage from these drums would flow directly into the channel.

Two extensive filled areas are located on the southern edge of the site. These areas support heavy vegetation and have been inactive for some time. Some refuse visible on one of the areas suggests that dumping may have occurred in this area.
